**CONSERVATORS OF THE RIVER CAM****MATTERS FOR DECISION****River traffic monitoring at Riverside and implications for the Conservators' Mooring Policy****1. Preamble***1.1 Purpose of the report*

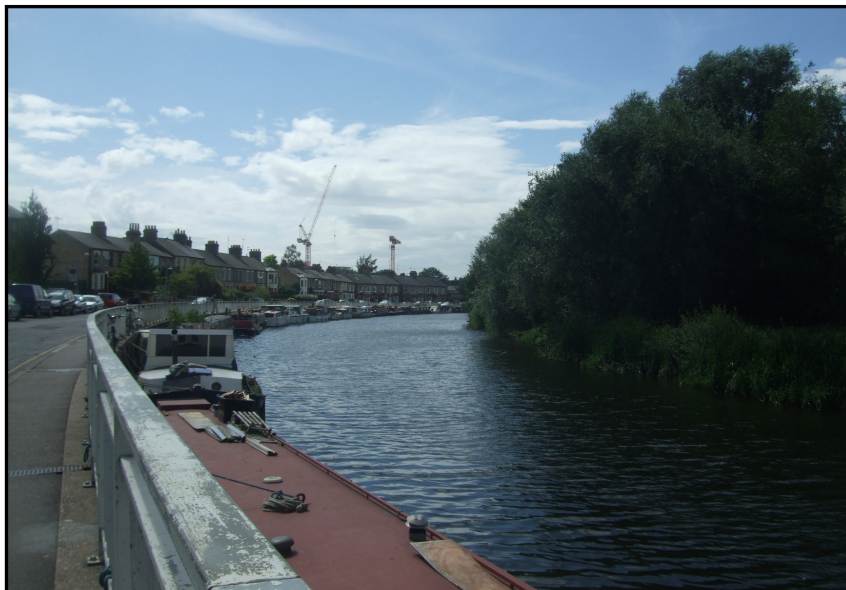
#### *Riverside – near cyclebridge opposite Logan’s Meadow Nature Reserve*

View upstream along a zone of mooring. Mooring zones are currently situated along the banks of Riverside, except for a prohibited zone along the right bank in front of the Museum of Technology. Vegetation encroachment here is limited.

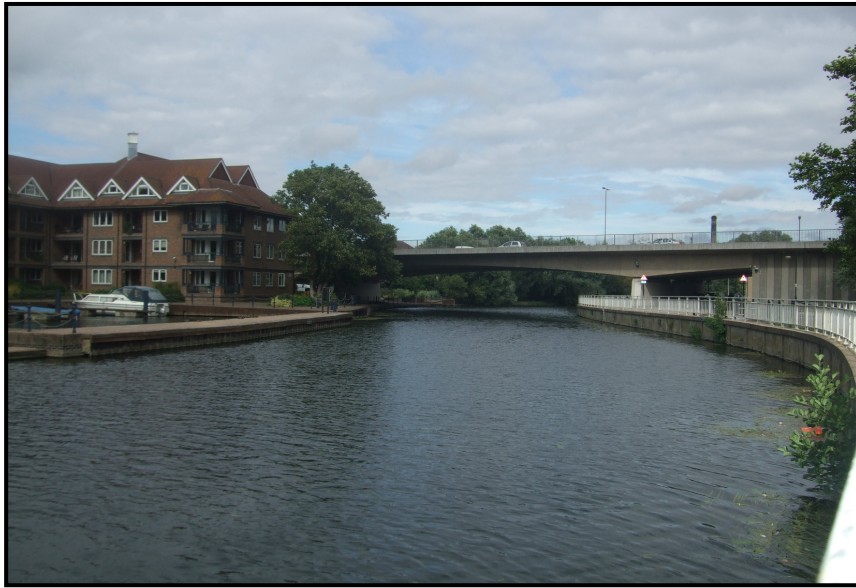
*Opposite Eights Marina*

View looking downstream towards Elizabeth Way Bridge.  
Mooring on either bank opposite Eights Marina is prohibited by the Conservators
